Case Report

Inferior vena cava - intrahepatic portal venous fistulas caused by cardiovascular foreign body

We report here a rare case of broken angiography catheter, occluding superior and inferior vena cava lasting for 11 years presenting as communication between IVC and portal veins.(Rawal Med J 2006;31:93-94)

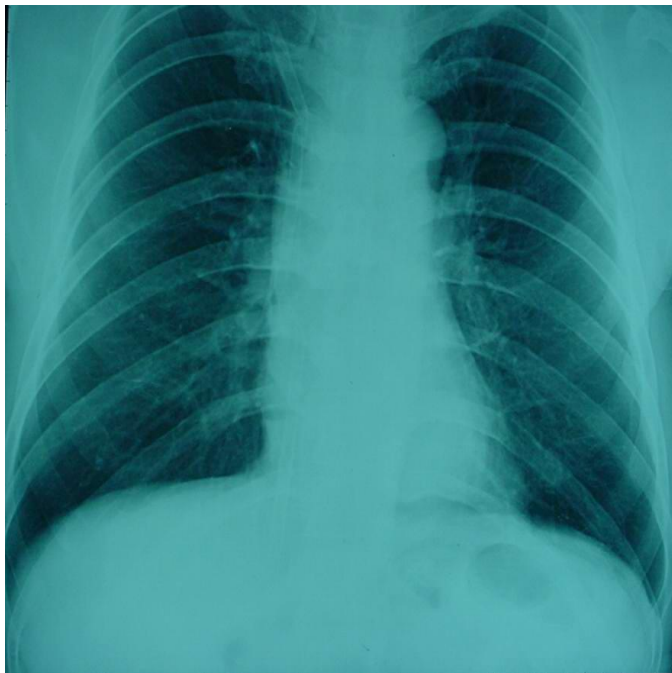
Fig.1. Chest X-ray shows an opaque catheter about 20 cm long, its tip is located in the right innominate vein, even partially entered into the right subclavian vein, the catheter goes down all the way passing through the superior vena cava, right atrium, and into the upper part of IVC

A 40-year old patient was admitted to Hospital on March 28, 2004 due to an X-ray finding of a catheter foreign body in the right chest (Fig.1) The patient had undergone mitral valve dilation for stenosis of bicuspid valve 11 years back. The inferior venocavography revealed a fistula between inferior vena cava (IVC) and portal vein (Fig. 2) and a beak like termination of the IVC pointing in line to the distal end of a broken angiographic catheter. The point below the distal end of foreign body is the location of the IVC occlusion. The occlusion was located in the IVC between the level of orifices of hepatic veins above and renal vein below, or within the length of the retro-hepatic IVC.

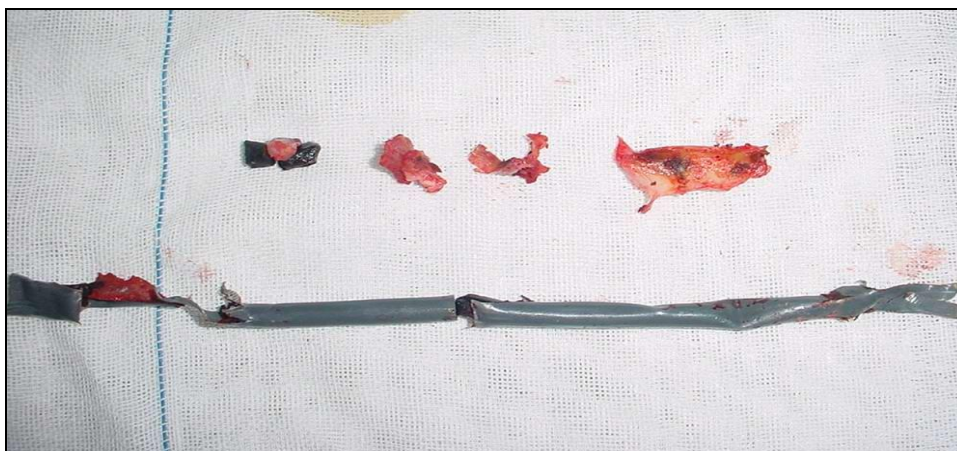
Fig.3. The removed broken catheter, fibrous tissue and thrombi.

On April 6, 2004, a right intercostal posterior-anterior thoracotomy was performed, and extracorporeal circulation with the venous drain from the left femoral vein and the left innominate vein, and arterial perfusion via the ascending aorta were installed. After cardiac arrest was secured by routine cardioplegia, the right atrium was opened along with the superior vena cava (SVC) and the angiographic catheter, was found well imbedded and fixed under a layer of calcified membrane, which was incised to expose the catheter. It was removed tediously part by part from atrium, SVC and finally from the IVC without incising its lumen. Most of the fibrous and fresh thrombi were extracted with the remained catheter (Fig.3). The right atrium was repaired with a patch of pericardium. Heart-lung machine was stopped and thoracic incision was closed in layers. The IVC – portal vein fistula was not treated, because of only mild IVC compressive syndrome. The patient developed postoperative pulmonary embolism and recovered with thrombolysis with urokinase. The bilateral limb edema was treated with medical stocking. Patient was discharged 3 weeks following surgery. Two years later, the patient did well.
